124 Anywhere Dr., Someplace, TN.

INSPECTION DATE: June 30, 2020

**PREPARED BY: BRENT SCOTT
PREMIER HOME INSPECTION LLC.**

REPORT SUMMARY

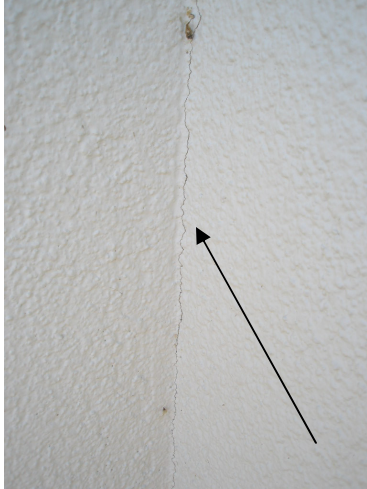
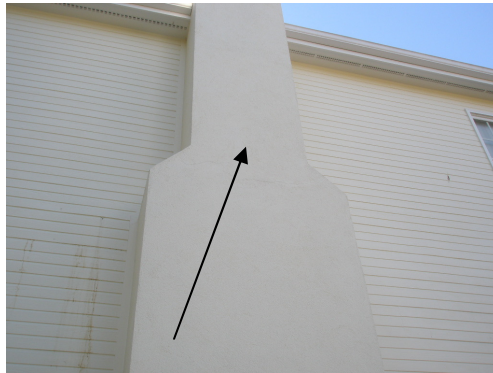
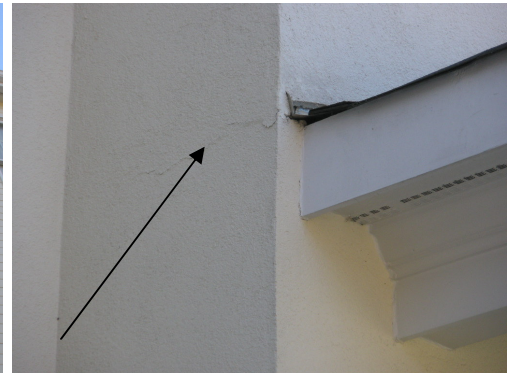
Exterior insulating and finishing system (EIFS) was noted on the front wall and chimney. Several cracks were noted in the EIFS. Cracks were noted on the chimney, above and below the left side of the front porch, and in the right corner of the garage on the front wall. It is recommended to have the home inspected by an EIFS specialist with repairs made as needed.

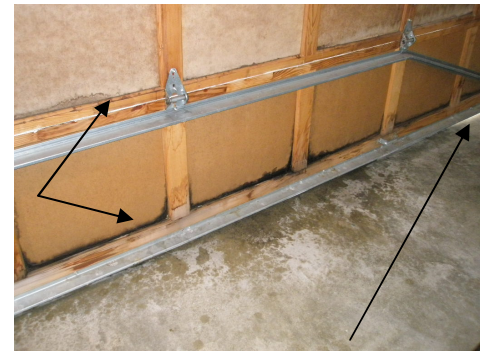
Soft wood was noted in the trim at the right side of the garage door. Repair as needed.

Moisture intrusion was noted through the panels in the garage door. It is recommended to caulk the gaps around the panels. Repairs should be made as needed.

Daylight was noted below the garage door. Additional weather stripping is recommended below the door.

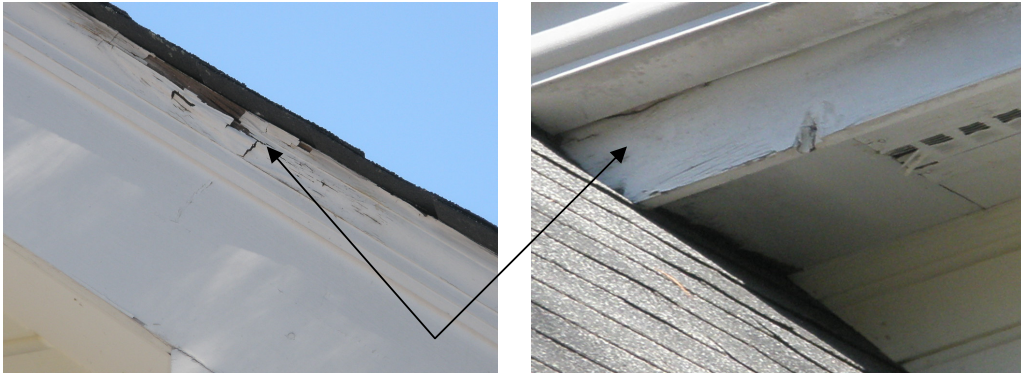
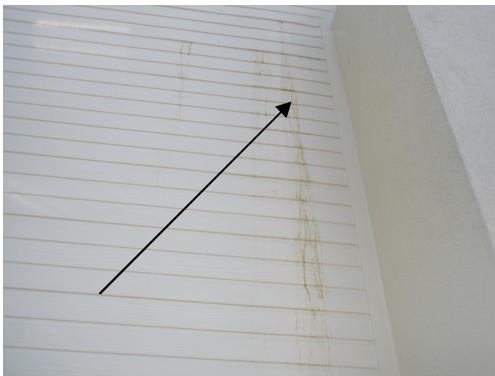
Deteriorated paint was noted on the wood fascia and drip edge on several areas around the exterior of the home. It is important to maintain the paint and caulk on all exterior wood surfaces to avoid damage from the elements. Repairs should be made as needed.

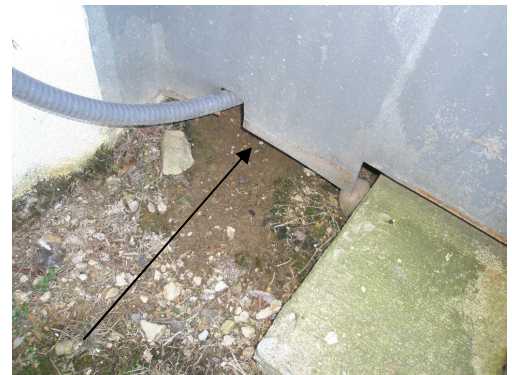
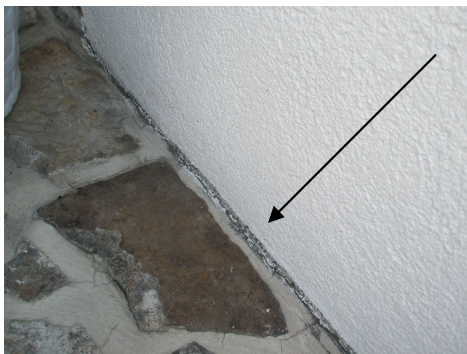
Stains were noted on the left wall behind the chimney. No moisture was noted in the stained areas on the lower section of the wall. This area should be closely monitored with repairs made as needed. (This is on the outside wall behind the master bathroom sink. The plumbing supply and drain lines terminate through the exterior wall.)

Gaps were noted below both sides of the shroud at the downstairs HVAC unit. It is recommended to seal the gaps to avoid pest intrusion into the crawlspace.

Moisture intrusion was noted around the outside band in the crawlspace behind the front porch. It is recommended to seal the gaps between the stone and front wall to avoid further moisture intrusion. Repairs were noted in the outside band behind the front porch.

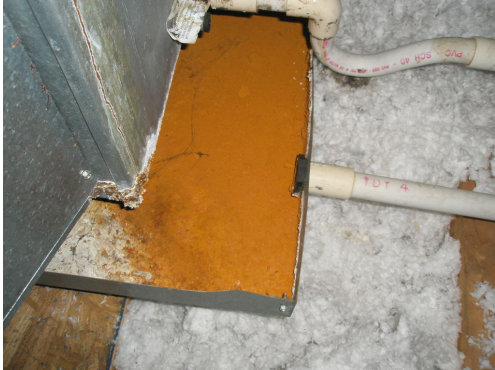
Rust stains were noted in the drain pan below the upstairs air handler. This is often an indication of problems with the cooling unit. The outside temperature was too low to run the cooling cycle at the time of inspection. This unit appears to be 17 years old. It is recommended to have the upstairs HVAC unit inspected by a qualified HVAC technician with repairs/replacement made as needed.

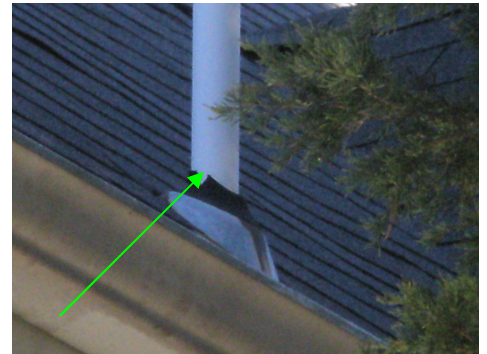
Several split flashings were noted on the plumbing vents on the roof. Moisture was noted below the vents in the attic space.

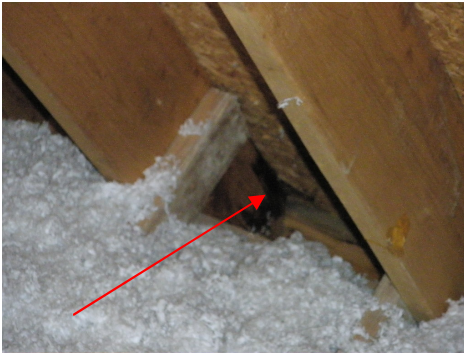
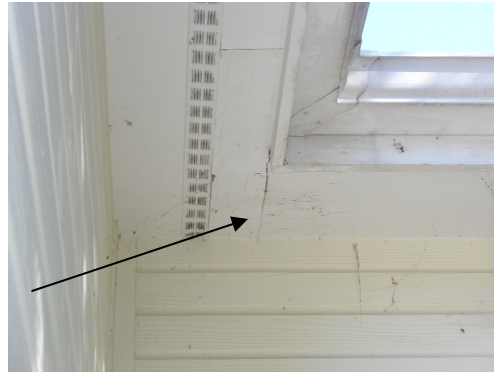
Moisture stains were noted on the rafters and roof decking on both sides of the outcrop above the kitchenette. Soft wood was noted in the soffits in this area.

- **Missing shingles were noted on the front slope above the garage/bonus room and above the front porch.**

It is recommended to have the roof inspected further by a qualified roofing contractor with repairs/replacement made as needed.

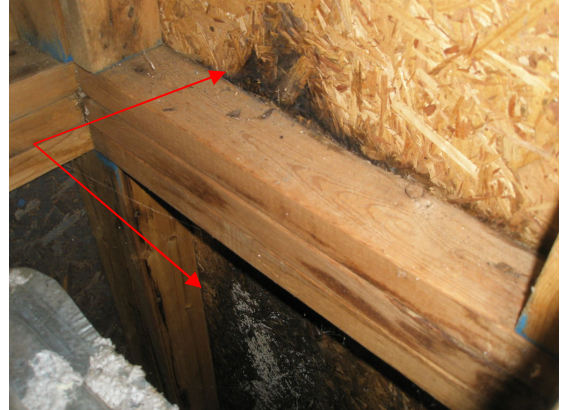
Moisture stains and soft wood was noted in the chimney box through the attic space. Further investigation is recommended by a qualified contractor with repairs made as needed.

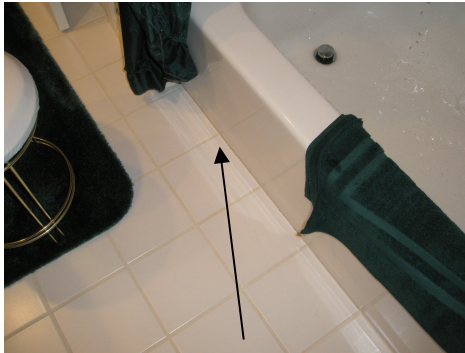
It is recommended to caulk the gaps between the tile floor and tub in the upstairs hallway bathroom to avoid moisture intrusion into the flooring.

- Cracked grout was noted in the kitchen floor. Repair as needed.
- A settling crack was noted in the sheet rock on the right side of the master bathroom door. Repairs should be made as needed.
- The Jacuzzi tub in the master bathroom did not operate when tested. Further investigation by a qualified plumber is recommended with repairs made as needed.
- The light above the Jacuzzi tub in the master bathroom did not turn on when tested. This is most likely due to a burnt bulb. Repair as needed.
- The faucet handles in the kitchen sink and downstairs bathroom sink leak when operated. Repair/replace as needed.
- The stopper in the upstairs hallway tub is a spring loaded pop up type. The springs rust over time. This stopper appears to be going bad. Repair/replace as needed.

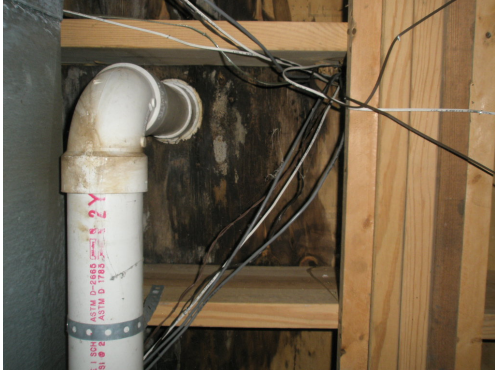
Moisture stains with soft wood was noted in the sub-flooring below the downstairs bathroom toilet. Further investigation is recommended by a qualified plumber with repairs made as needed.
